DAMAGE ASSESSMENT FORM

Building Name STRANO RESIDENCE

Address 24830 S.W. 187 AVE

Owner VITO & LORENE STRANO

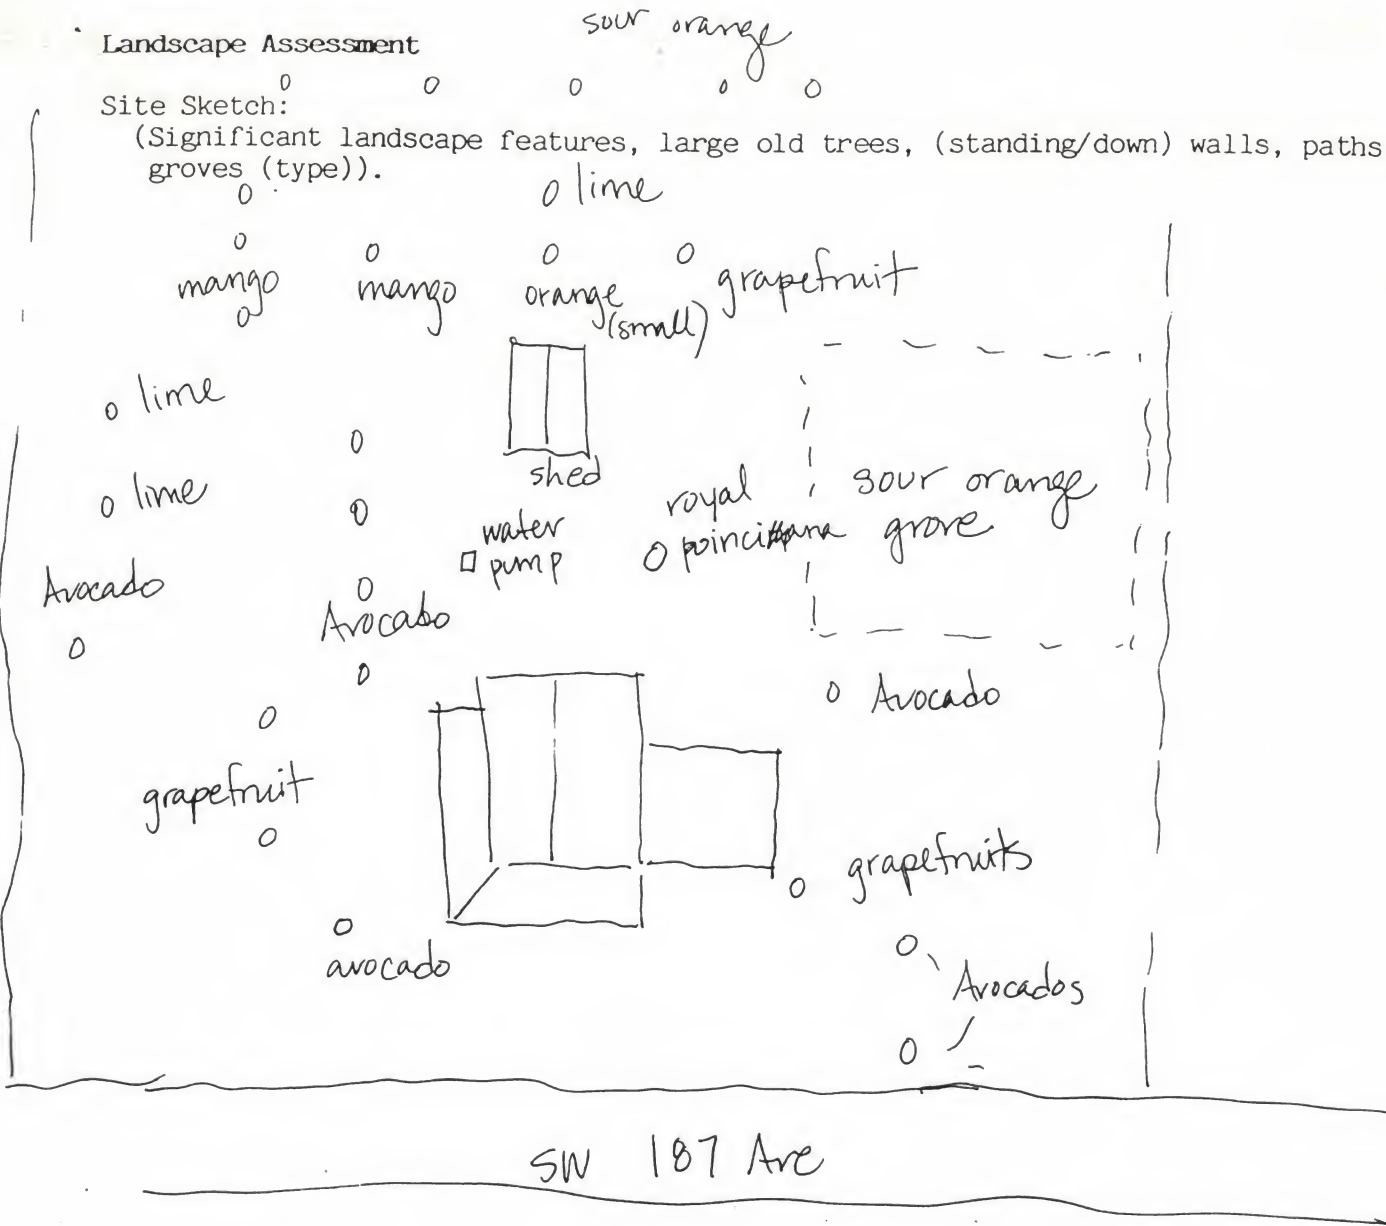
Site Sketch:

- Comments:
- Extensive collection of fruit trees, esp. grapefruit, sour orange, avocado
 - it looks as if avocado trees had been cut in the past and have regenerated, so the trees that are standing may be saved if trimmed.
